## Field Monitoring Report -- Pebble Copper/Gold Exploration Project --

Personnel: Bill Cole, DNR, Mining Section	Inspection Date: 9/14/2011
Mike Walton, DNR, Water Section	Site Contact: Jeff Norberg
	APMA #: A116118
<b>■ Inspection Type:</b> <input type="radio"/> Complete: X <input type="radio"/> Partial: <input type="radio"/> Follow-up: <input type="radio"/> Response to Public Complaint:	<b>■ Wildlife Observed:</b> <input type="radio"/> Bear: 1 black bear <input type="radio"/> Caribou: <input type="radio"/> Moose: <input type="radio"/> Waterfowl: Approximately 10 swans, 1 raven <input type="radio"/> Fish: <input type="radio"/> Other:
<b>■ Weather Conditions:</b> <input type="radio"/> Temperature: 40-45° F <input type="radio"/> Wind: 15-20 mph <input type="radio"/> Precipitation: Rained part of the day <input type="radio"/> Visibility: 15 miles <input type="radio"/> Sky Conditions: Overcast <input type="radio"/> Ground Conditions: Wet	
<b>■ Comments:</b> Inspected the Big Wiggly Lake fuel storage site. There was a small spill of fuel onto the tundra on September 13, 2011, the day prior to this inspection. The spill was <2 gallons, and will be reported in the 30-day report to ADEC

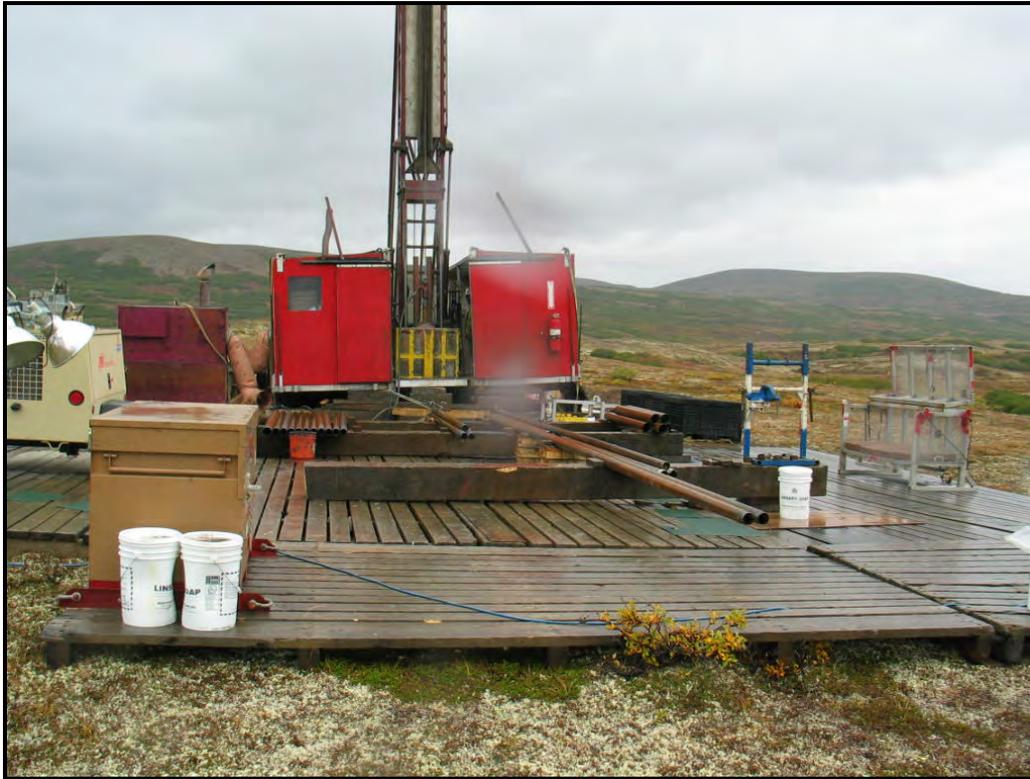
Photo #1. Drill #3 on DDH 11537.

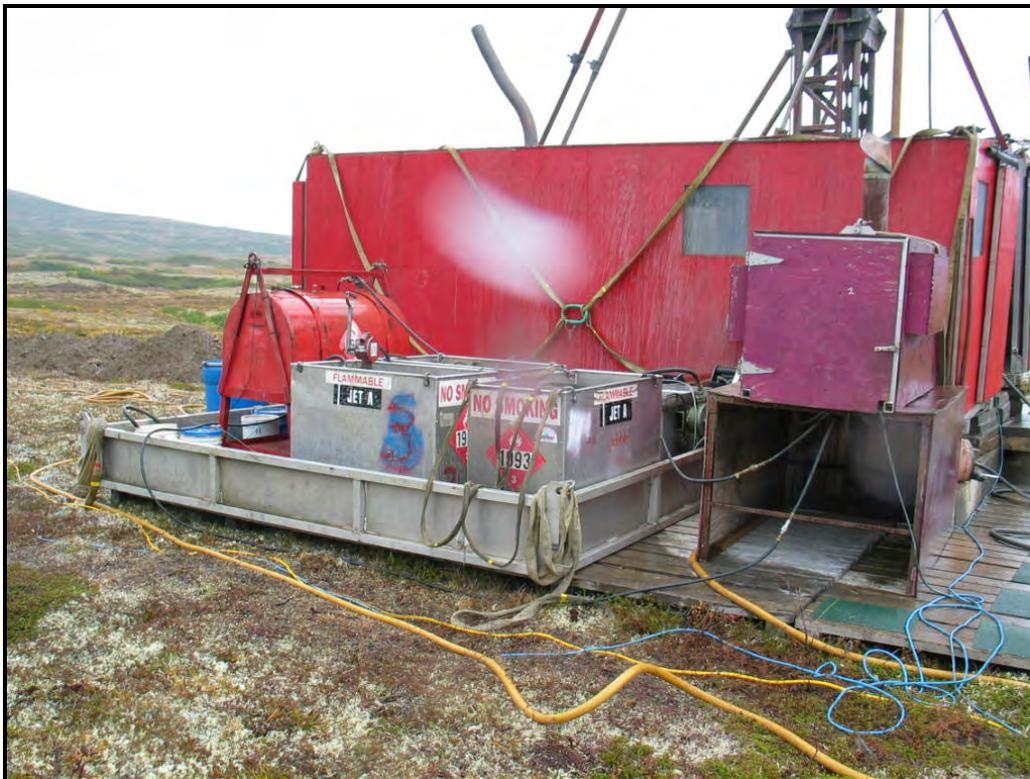
Photo #2. Fuel supply for drill #3.

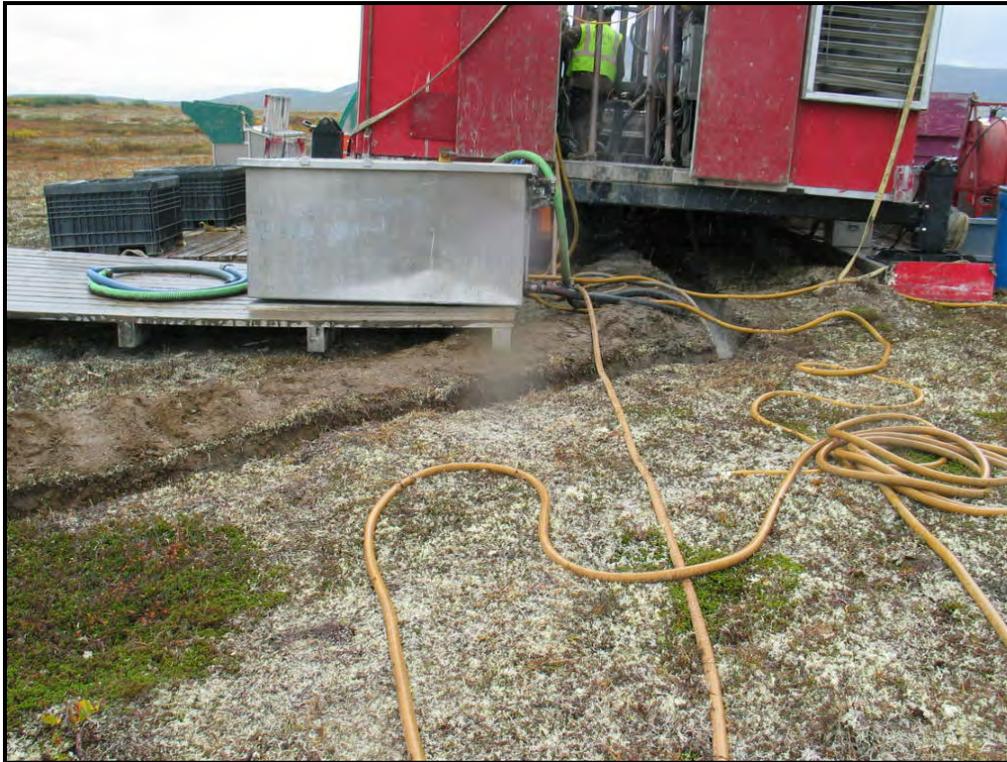
Photo #3. Discharge trench at drill #3.

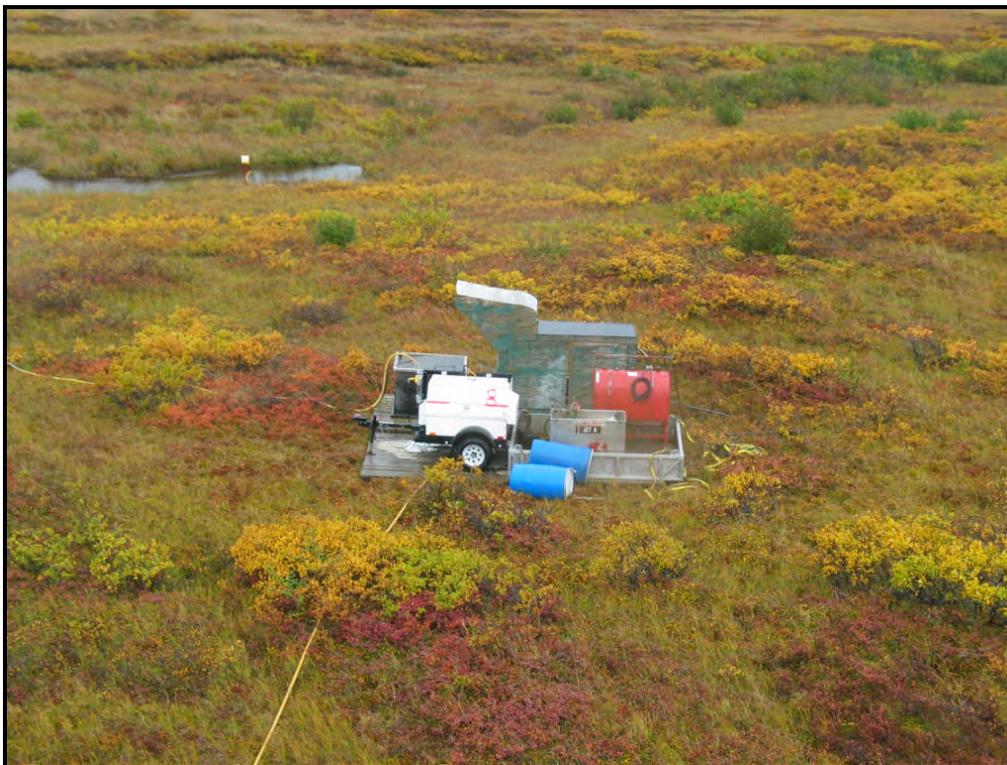
Photo #4. Water pump generator and fuel supply for DDH 11537. Water source and takepoint in background.

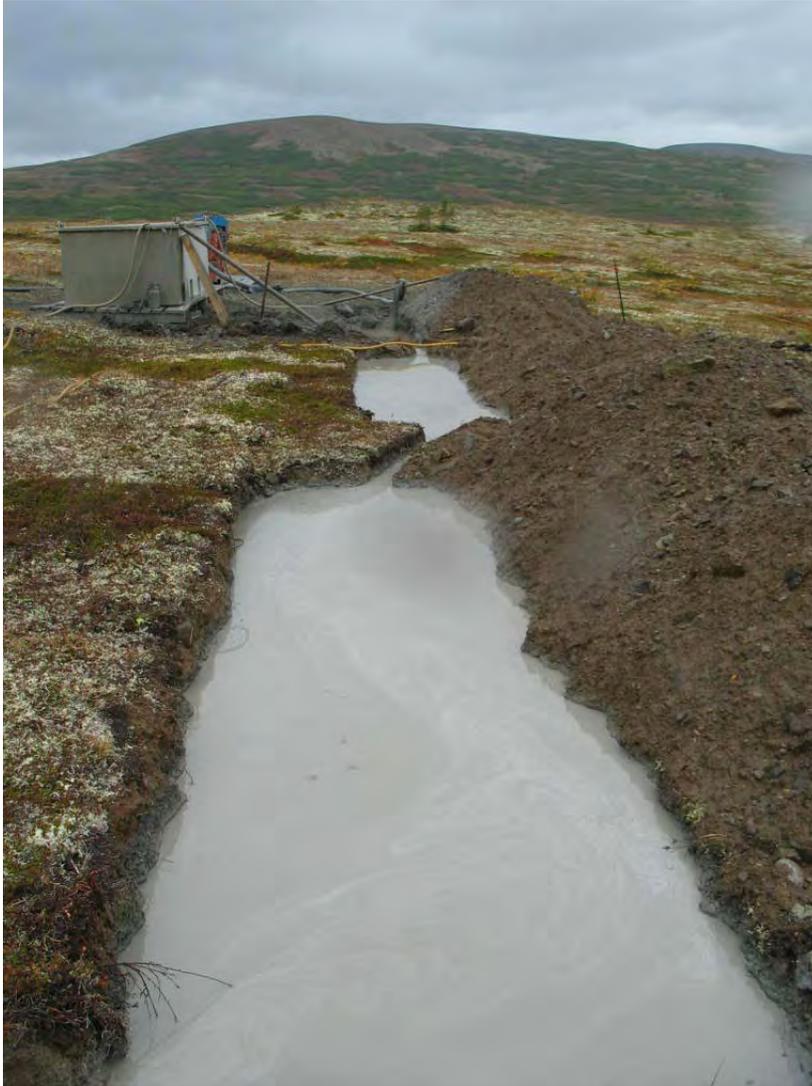
Photo #5. Sump pits and mud tank at DDH 11537.

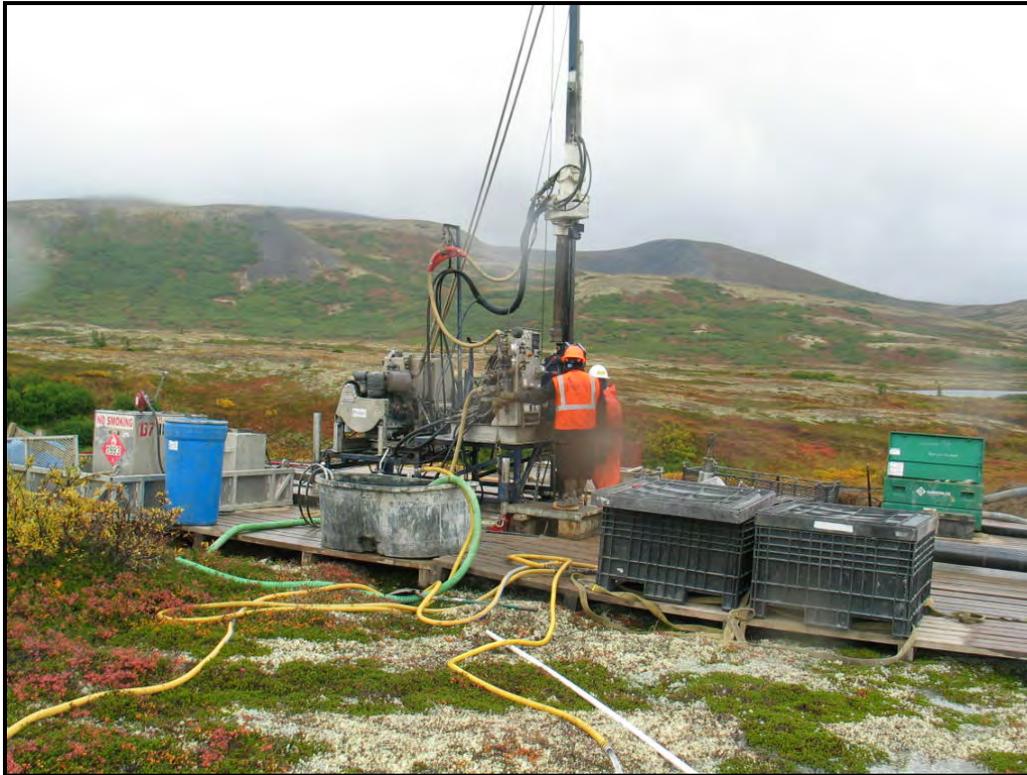
Photo #6. Dril #4 on Geo-tech hole SH11-AP.

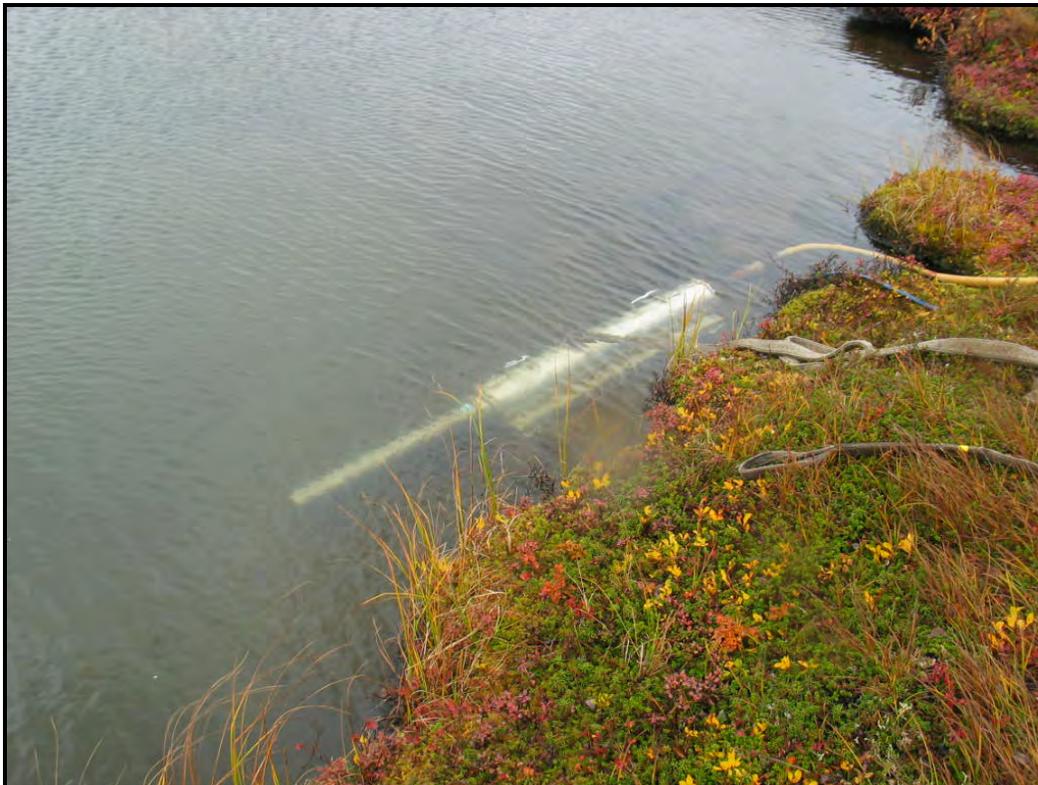
Photo #7. Water intake for SH11-AP.

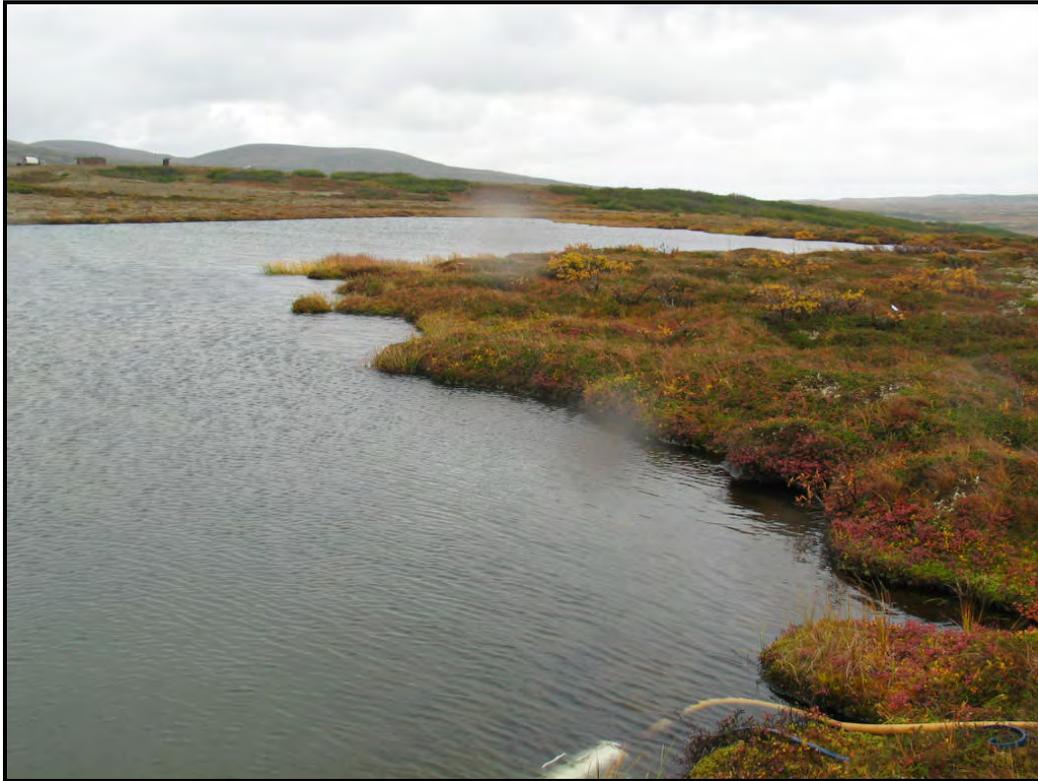
Photo #8. Water source for SH11-AP. Pond was bank full.

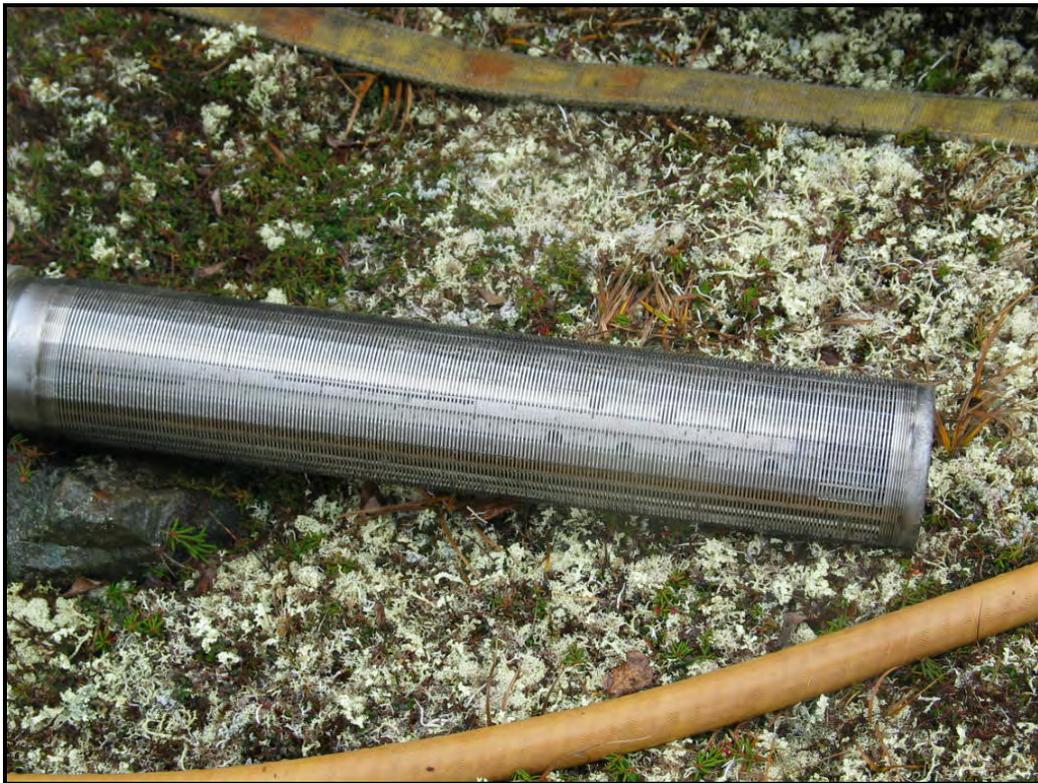
Photo #9. Water intake mesh typically used at Pebble Project. Mesh size is 1 mm.

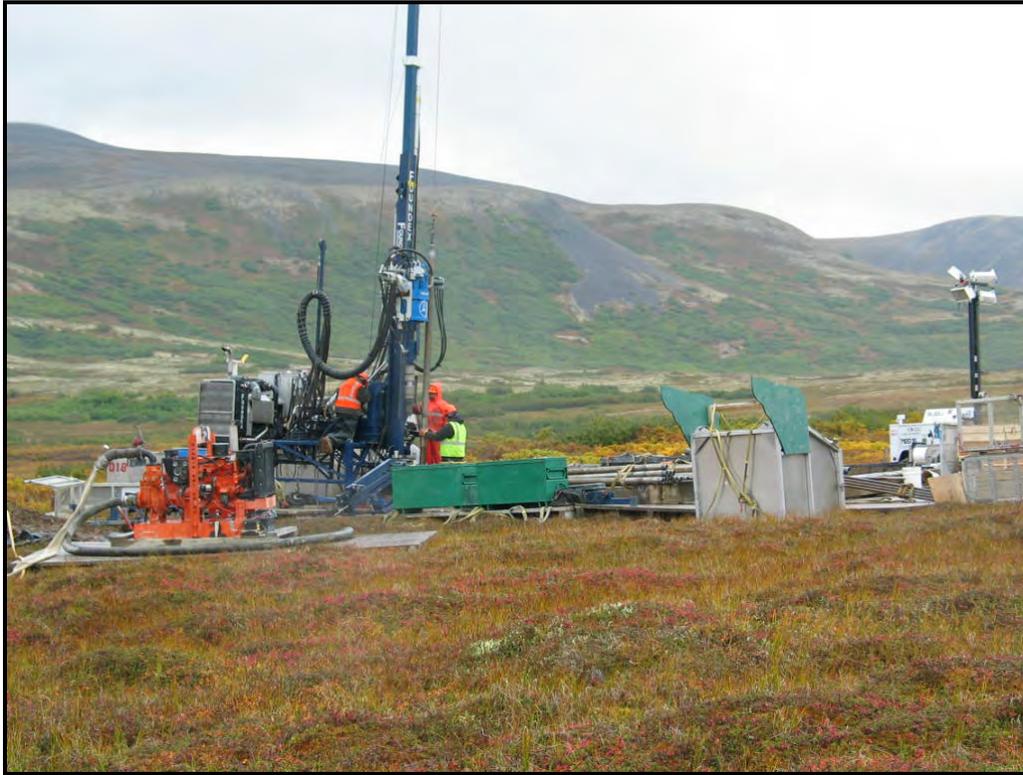
Photo #10. Drill #5 on GH11-272S.

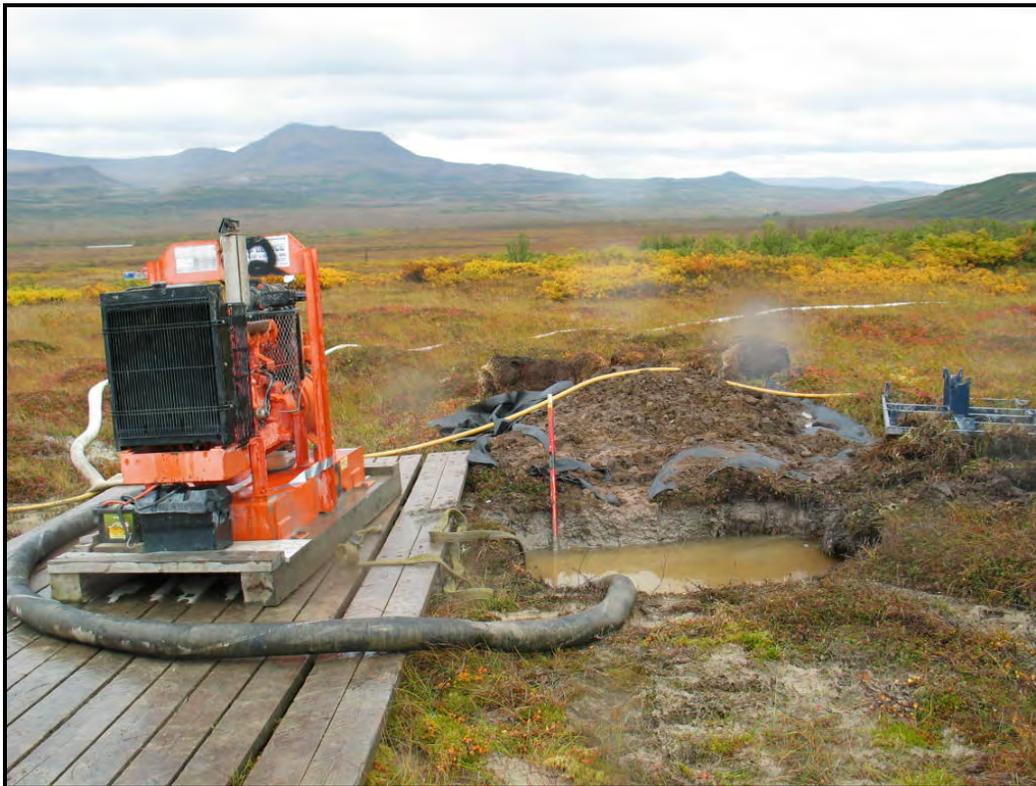
Photo #11. Sump pit at GH11-272S. Black plastic under stockpiled sump material is placed to protect tundra.

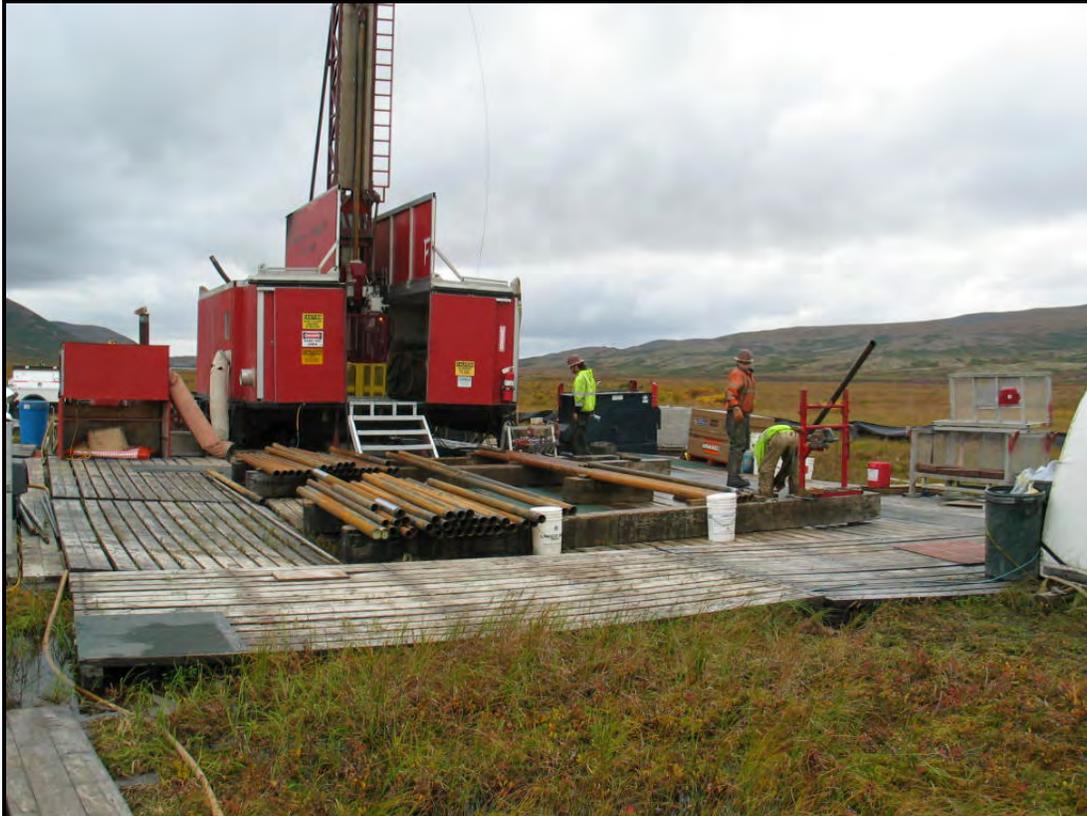
Photo #12. Drill #2 on DDH 11536.

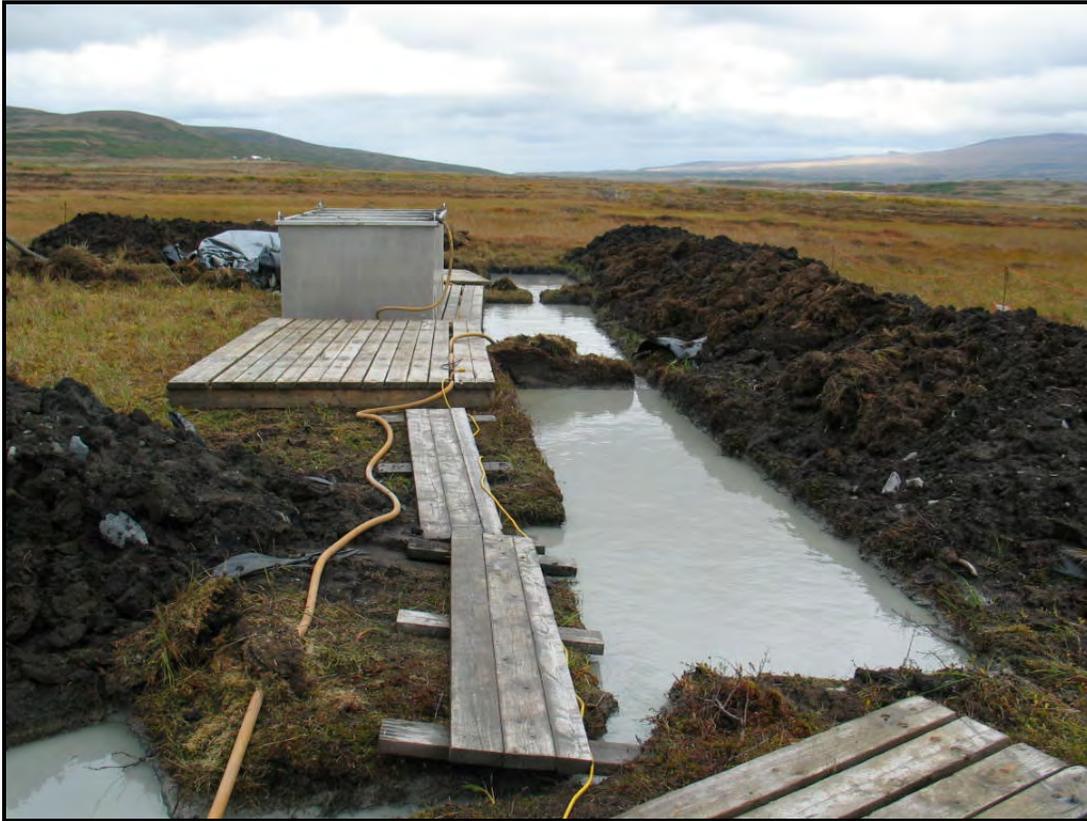
Photo #13. Sump pits at DDH 11536. Tundra pads to protect wetland.

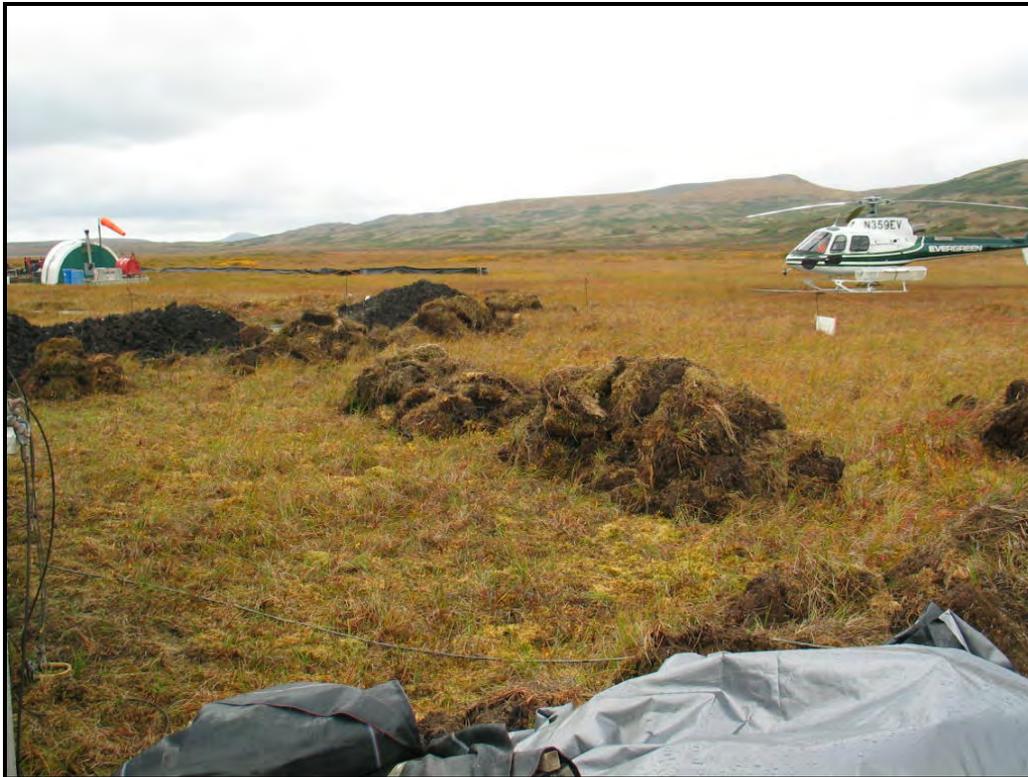
Photo #14. Stockpiled tundra at DDH 11536.

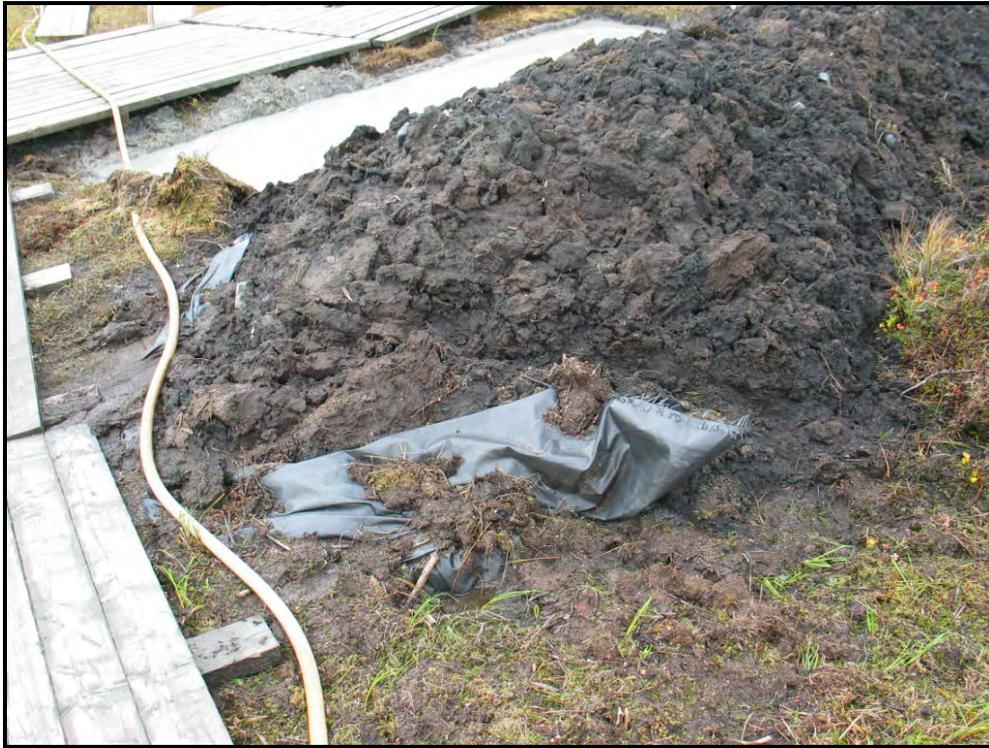
Photo #15. Stockpiled fill from mud sump. The black plastic is now being laid down beneath the fill to protect tundra.

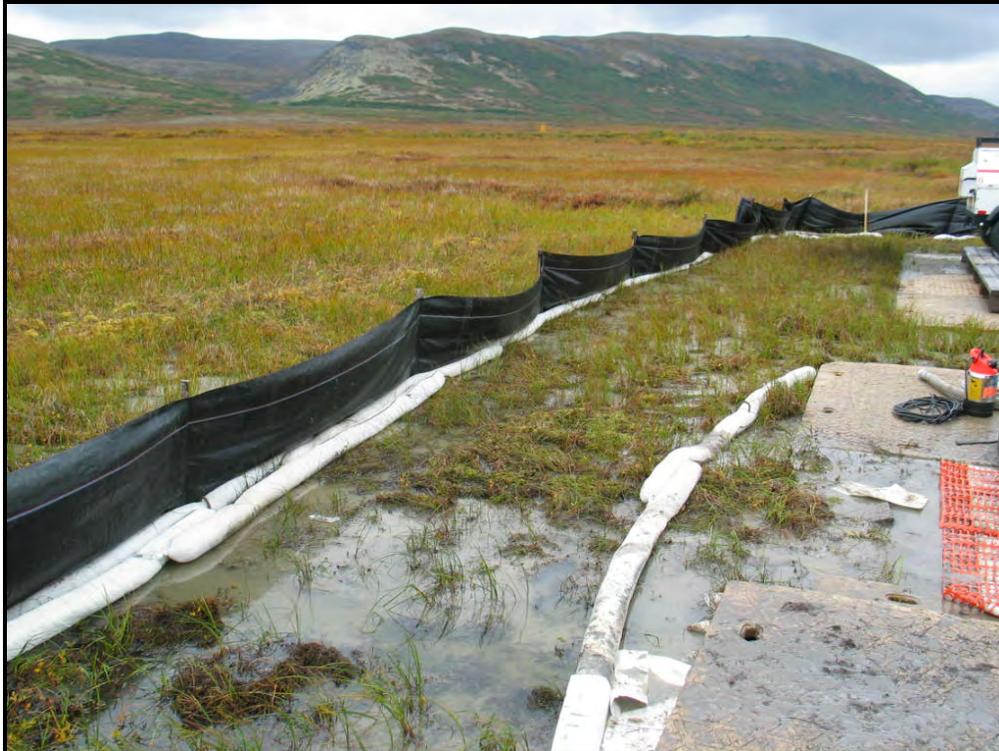
Photo #16. Silt screen and sorbent tubes to prevent silty water from drill entering wetland.

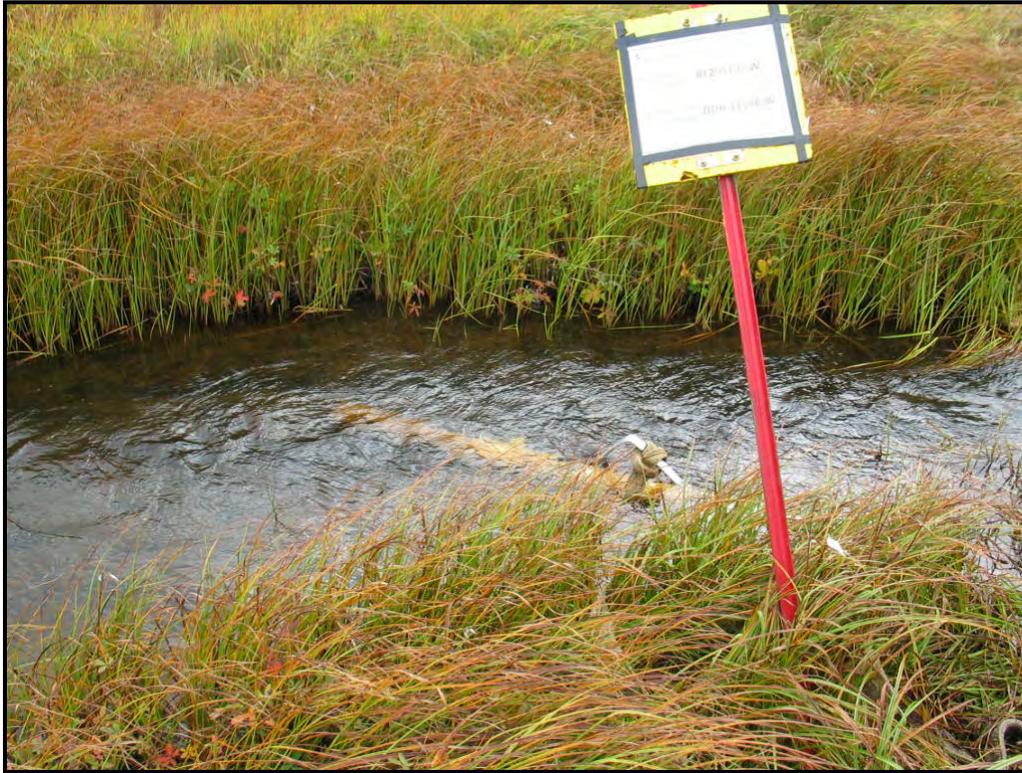
Photo #17. Water intake for DDH 11536.

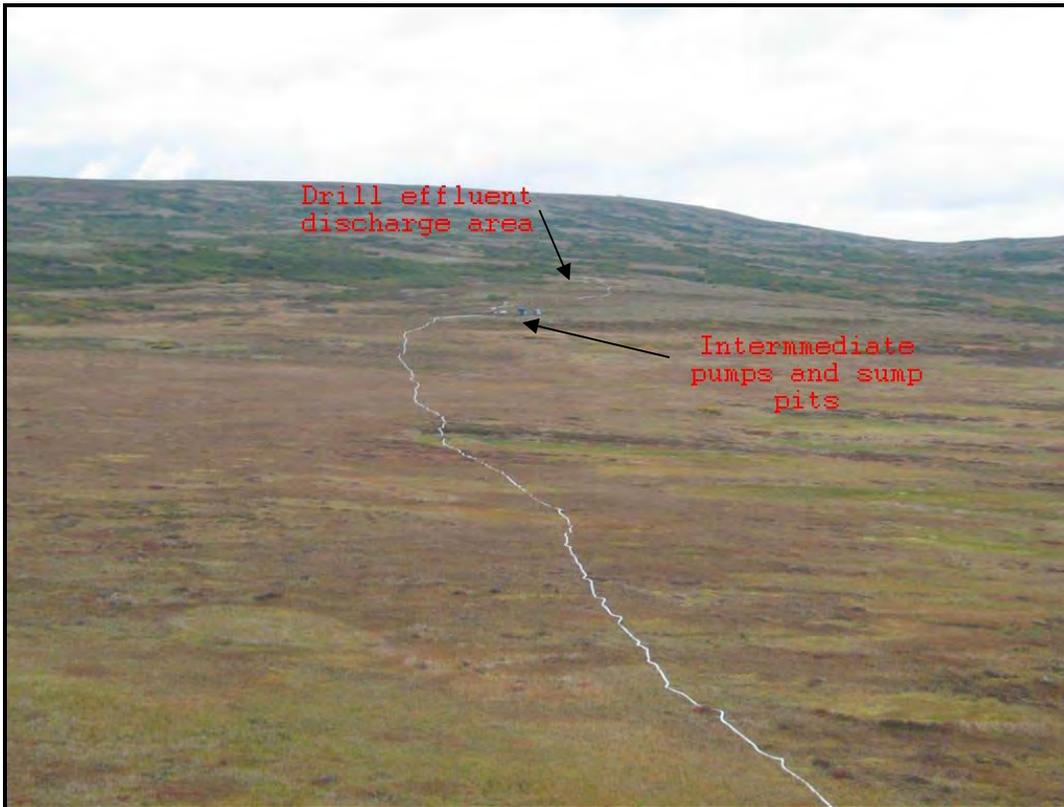
Photo #18. Drill effluent discharge line from DDH 11536.

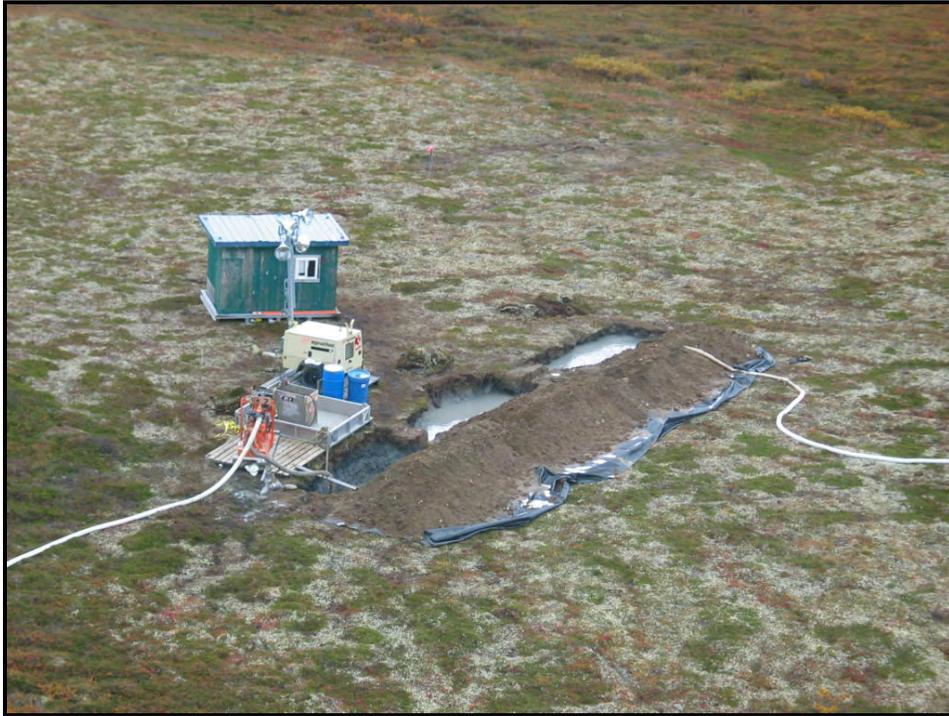
Photo #19. Intermediate pump station and sump pits above DDH 11536. Intermediate pump was needed to transport drilling effluent away from wetland.

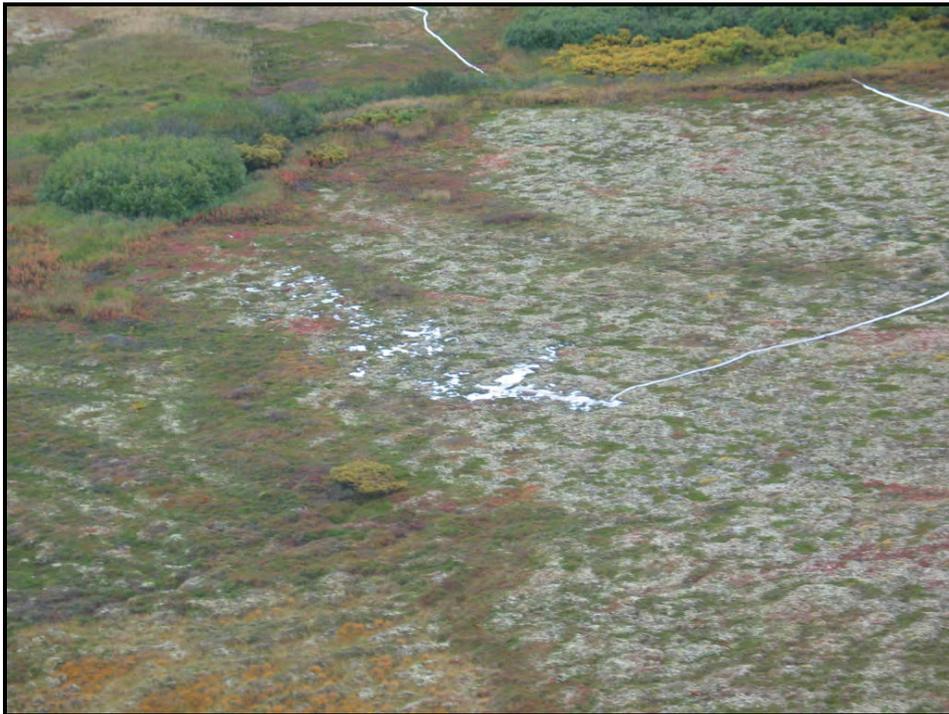
Photo #20. Drill discharge area from DDH 11536.

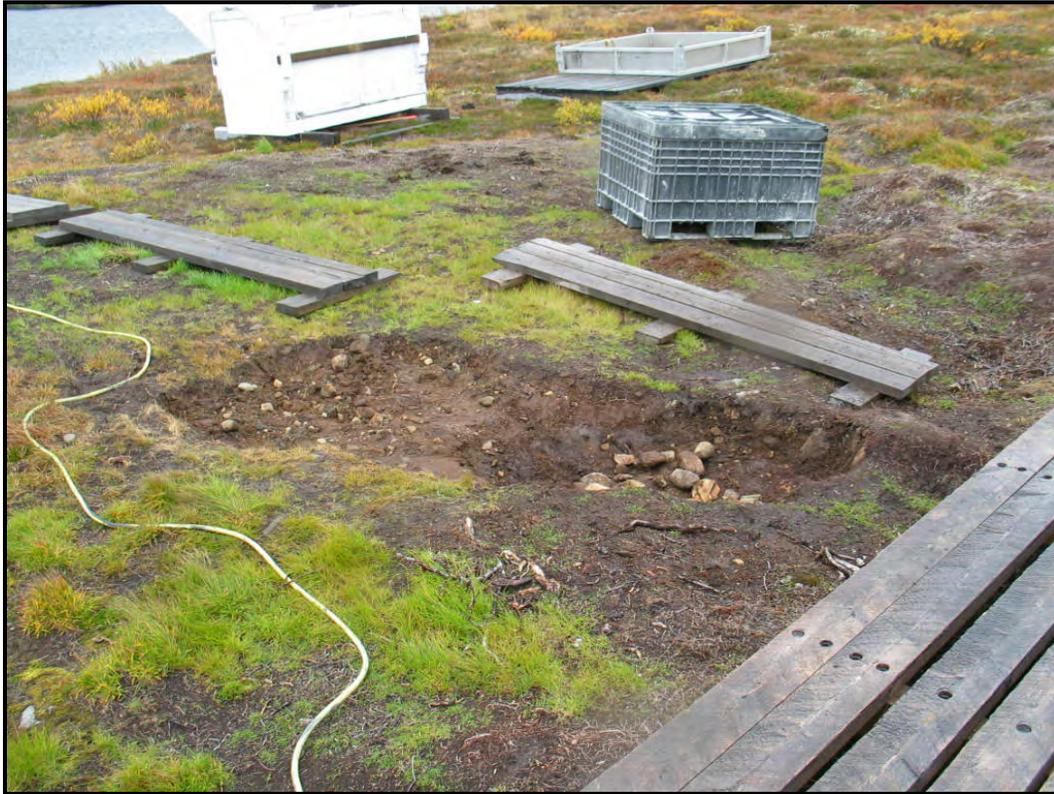
Photo #21. Area of September 13, 2011 fuel spill at Big Wiggly Lake.

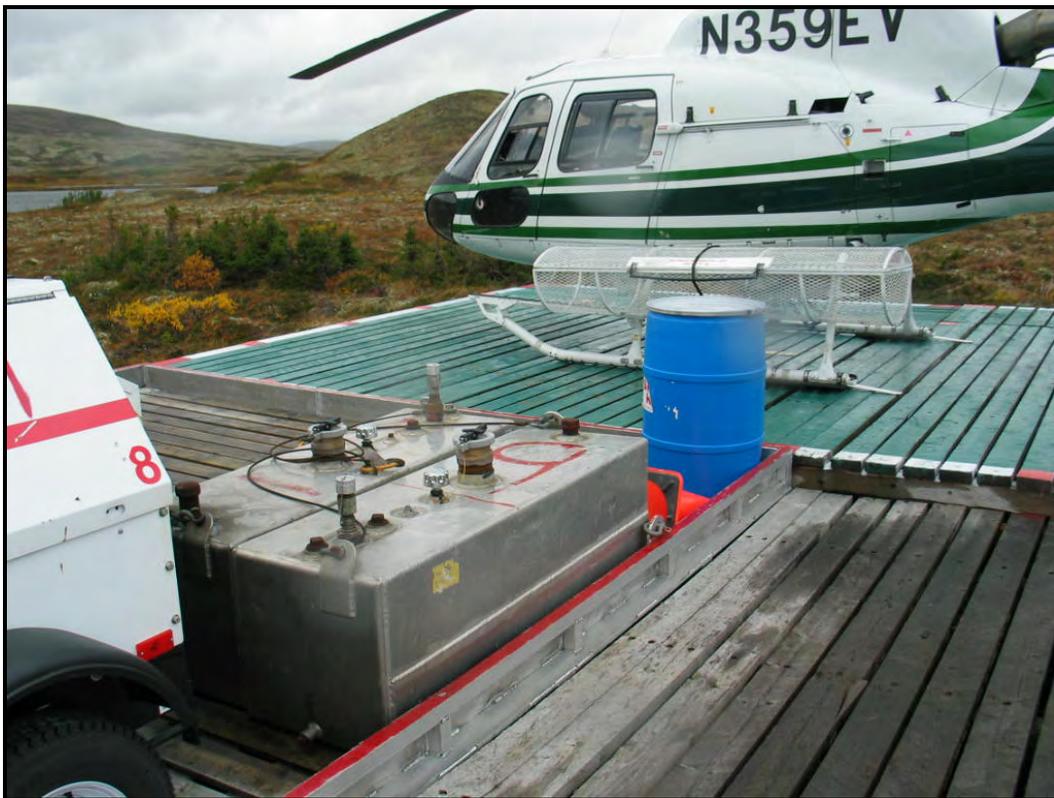
Photo #22. Helicopter fueling facility at Big Wiggly Lake.
